December 9, 2011

Subject: Work Summary and Visual Performance Evaluation
Building 6, Level 600/700 Paint Removal
Rainier Commons Facility
3100 Airport Way South
Seattle, Washington

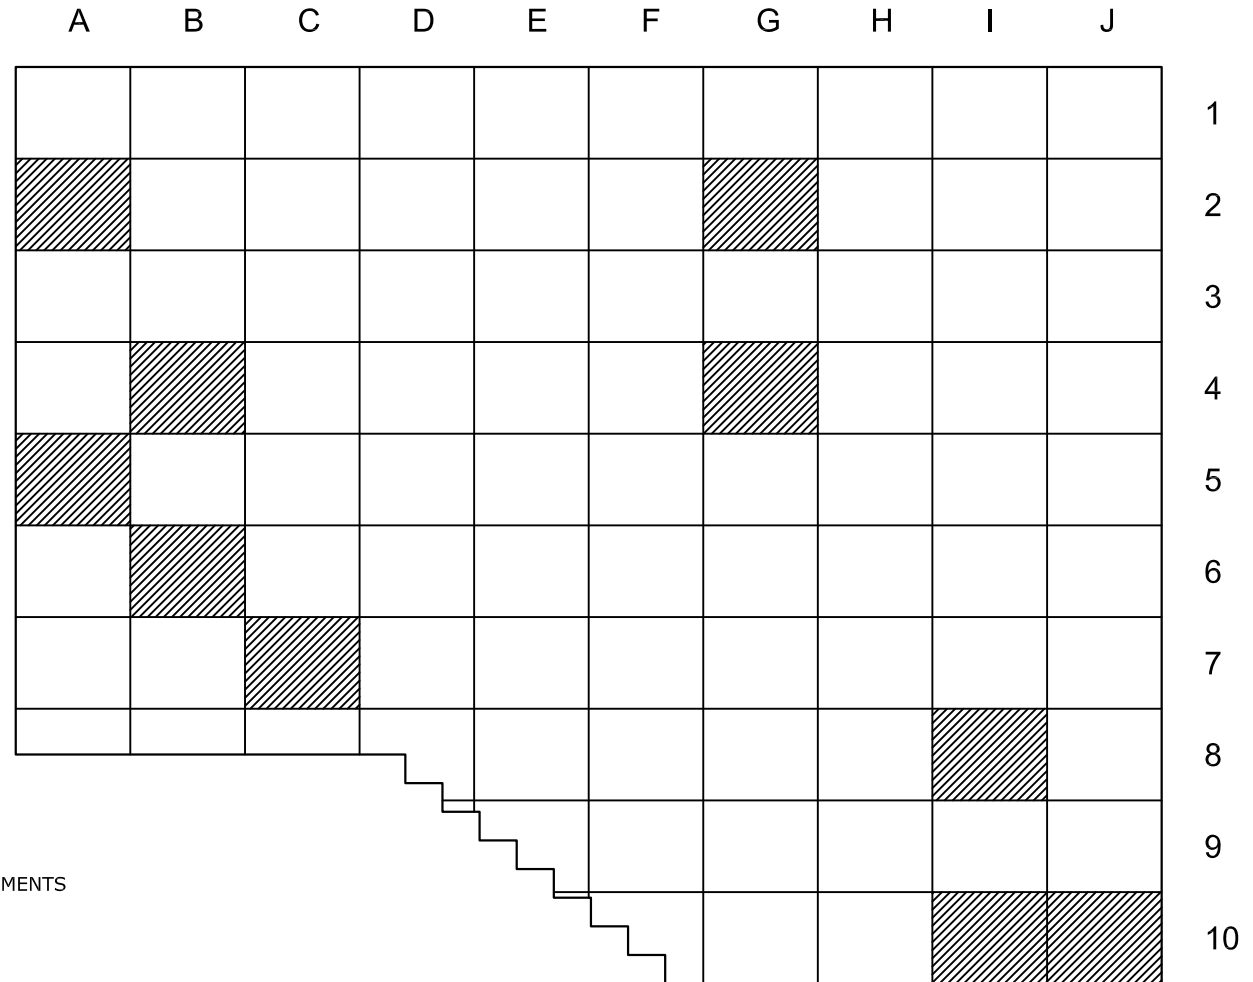
Figure No. 1
Brick Wall Visual
Inspection Grid Layout

The brick substrate consisted of one wall, which had an overall horizontal dimension of 25-feet (ft) and overall height of 20-ft. The overall sample area was reduced by a 5-ft tall staircase and landing running parallel with the wall starting approximately in the center of the wall at the bottom (see **Figure 1**).

The randomly-selected brick grid elements are identified below and shown on **Figure 1**:

Brick – A2, A5, B4, B6, C7, G2, G4, I8, I10, J10

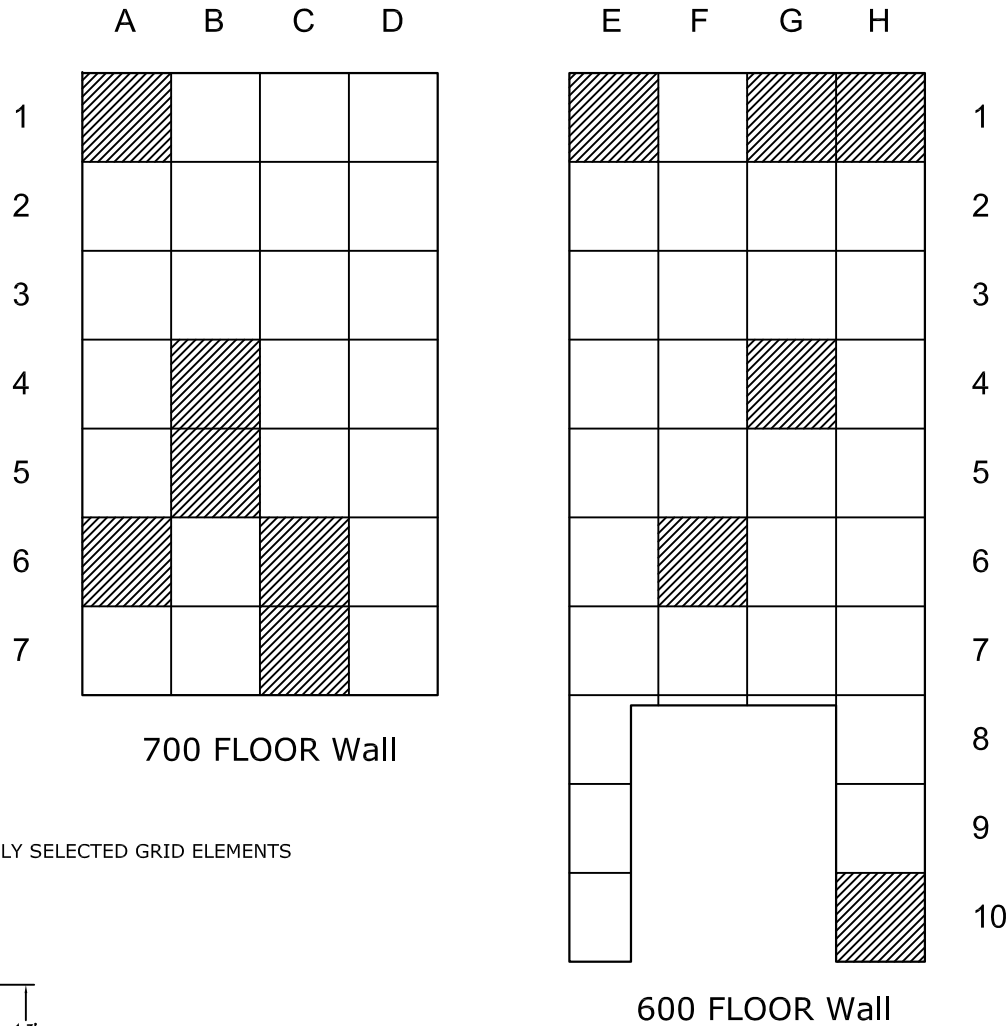
Figure No. 2
Concrete Wall Visual
Inspection Grid Layout

As agreed between CDM and the EPA during a site visit on the first day of sampling, six grid elements were randomly selected from each concrete wall for visual inspection. Special consideration was made for the Level 600 concrete wall, which had three distinctly different substrate types: cast-in-place wall, cast-in-place foundation, and a cinder-block patched area. The location of this wall also made collecting representative samples a safety concern as part of it extended over an open stairway. Due to both the material differences and safety concerns, CDM and EPA agreed that the concrete samples in the lower level concrete wall would be collected from each of the different concrete types regardless of the random selection. The randomly-selected concrete grid elements are identified below and shown in **Figure 2**:

Concrete 700 Level Wall – A1, A6, B4, B5, C6, C7

Concrete 600 Level Wall – E1, F6¹, G1, G4, H1, H10

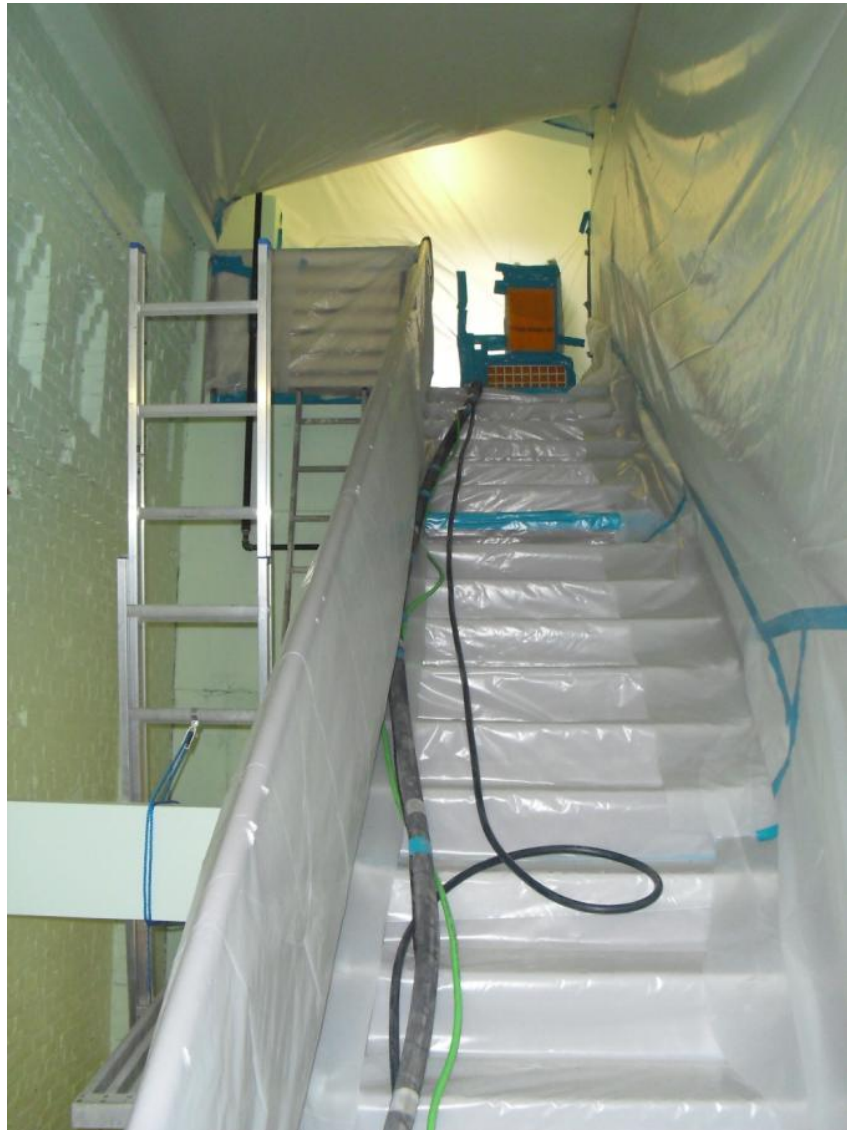
Photograph No. 1

Prior to site work, the work area was fully enclosed with plastic visqueen sheeting (**See Photo 1, Attachment A**). At a minimum, personal protective equipment (PPE) consisted of

Description: Containment
area.

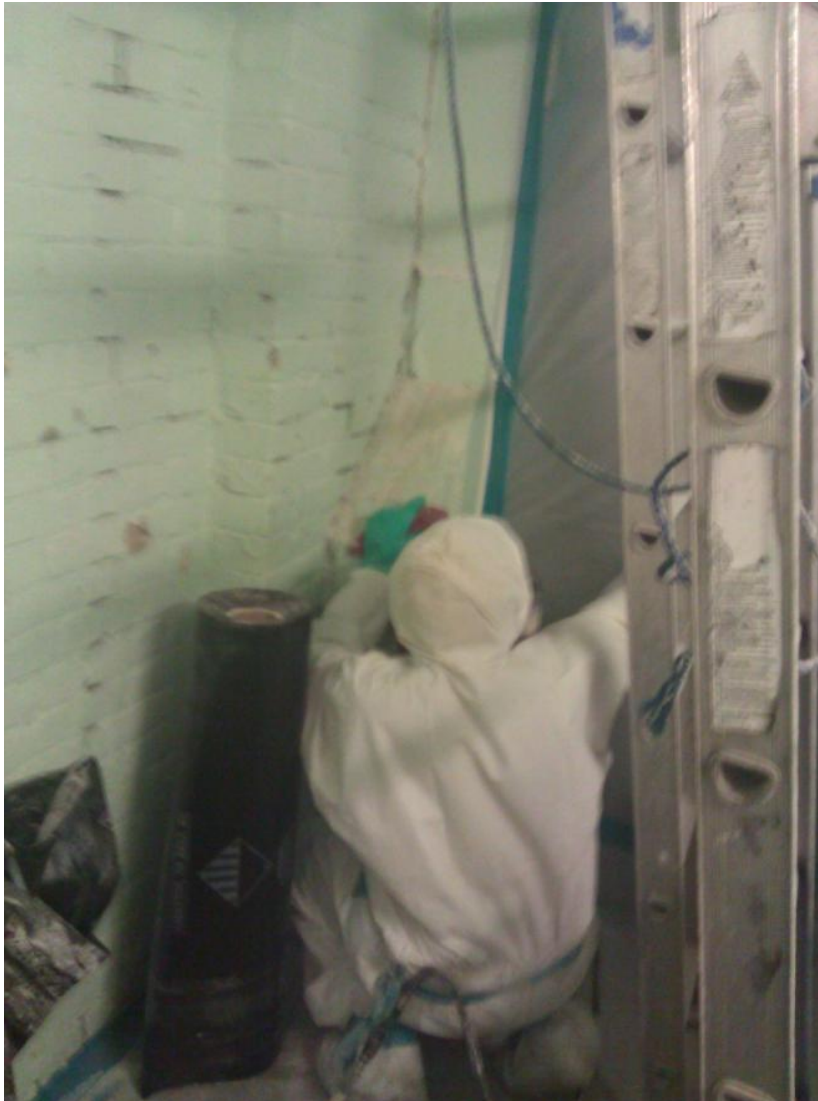
Photograph No. 2

Description: Workers
attempting to scrape paint
from the wall.

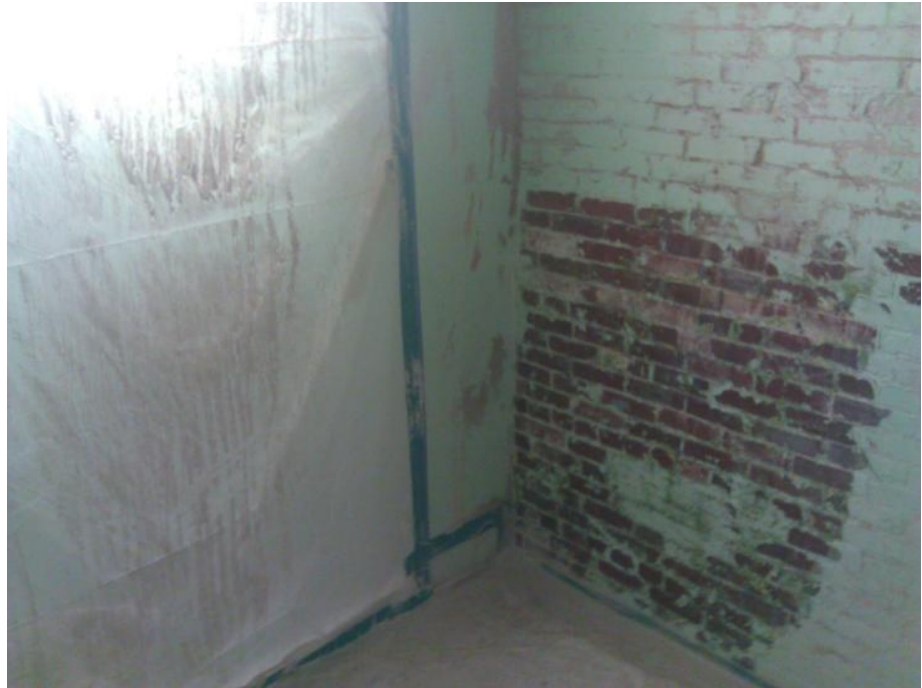
Photograph No. 3

Description: Partial paint removal on the brick wall using soda ash.

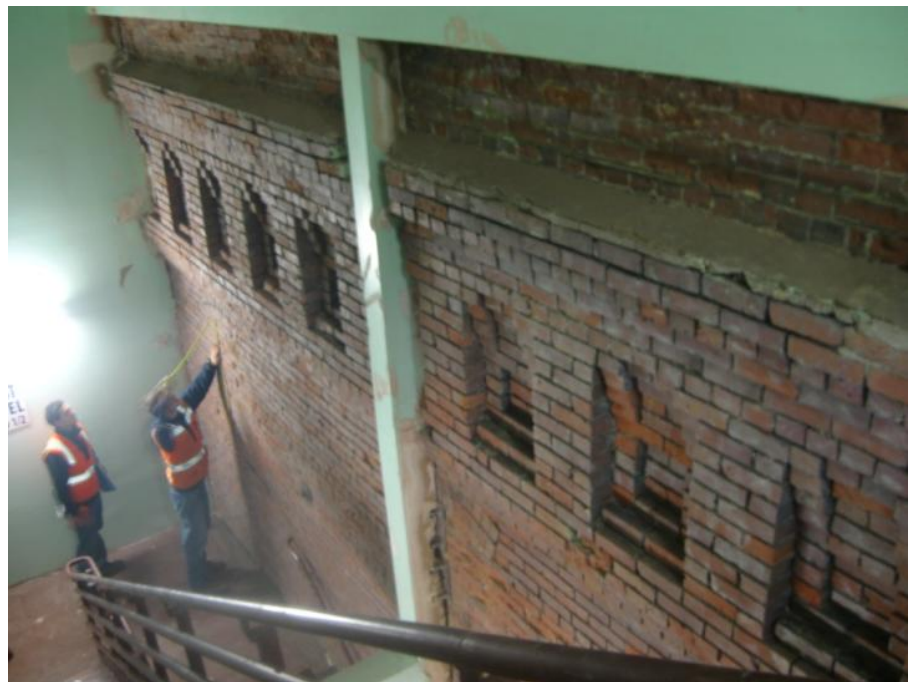
Photograph No. 4

Photographs showing the overall conditions of the brick and concrete walls following paint removal are included in **Attachment A, Photos 4 through 6**. From a casual observation, residual paint was hardly noticeable on any of the surfaces.

Description: View of brick wall post abatement viewed from Level 700.

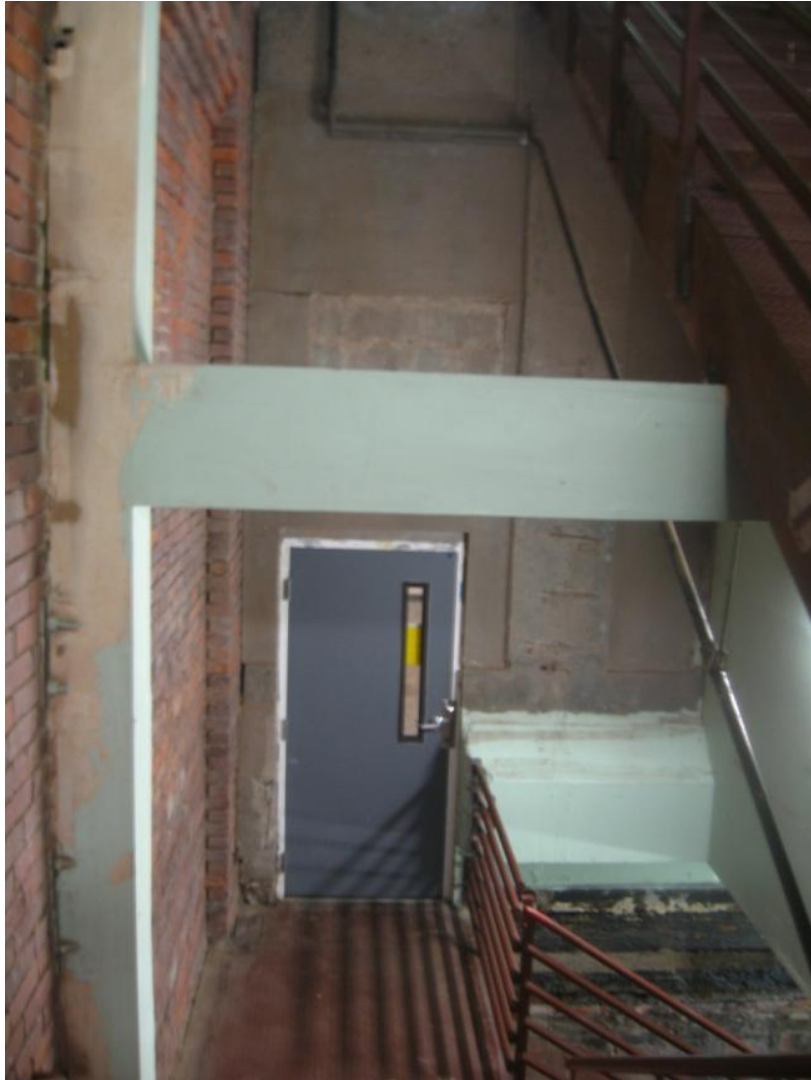
Photograph No. 5

Description: View of concrete
wall on Level 600 post
abatement.

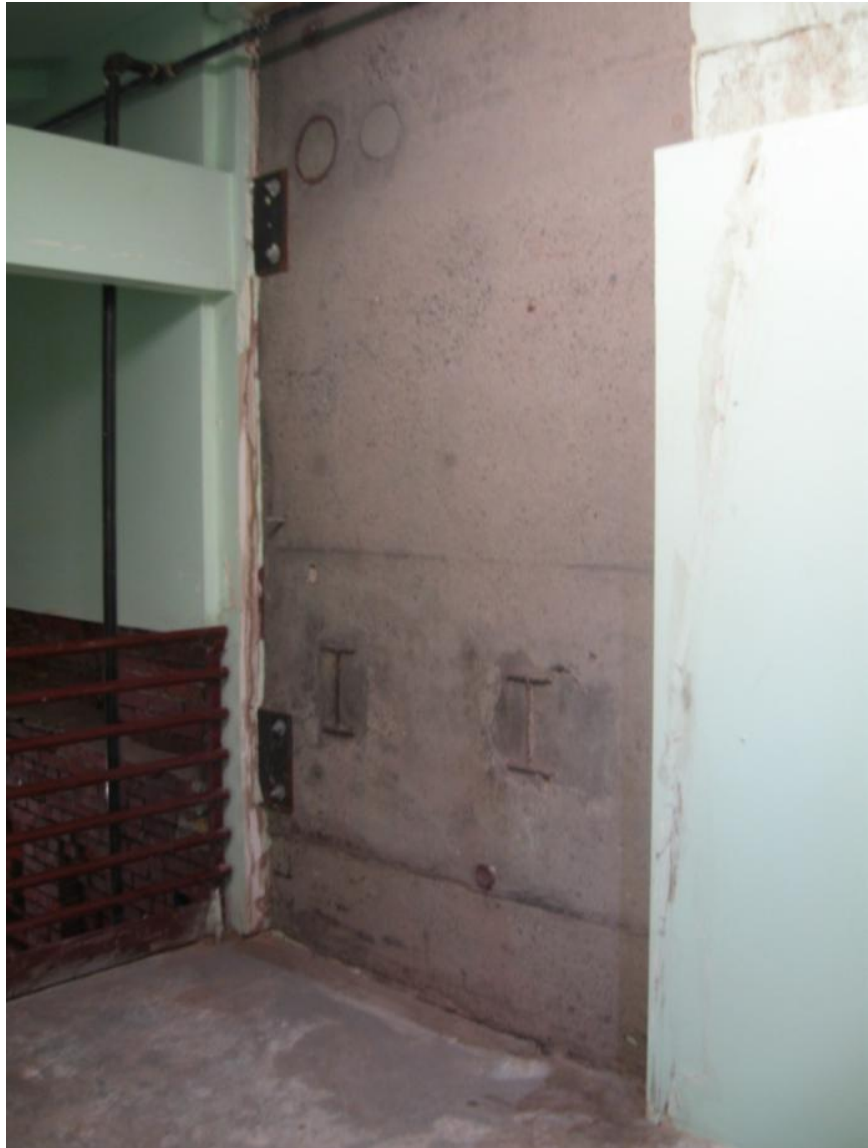
Photograph No. 6

Description: View of
concrete wall on Level 700
post abatement.

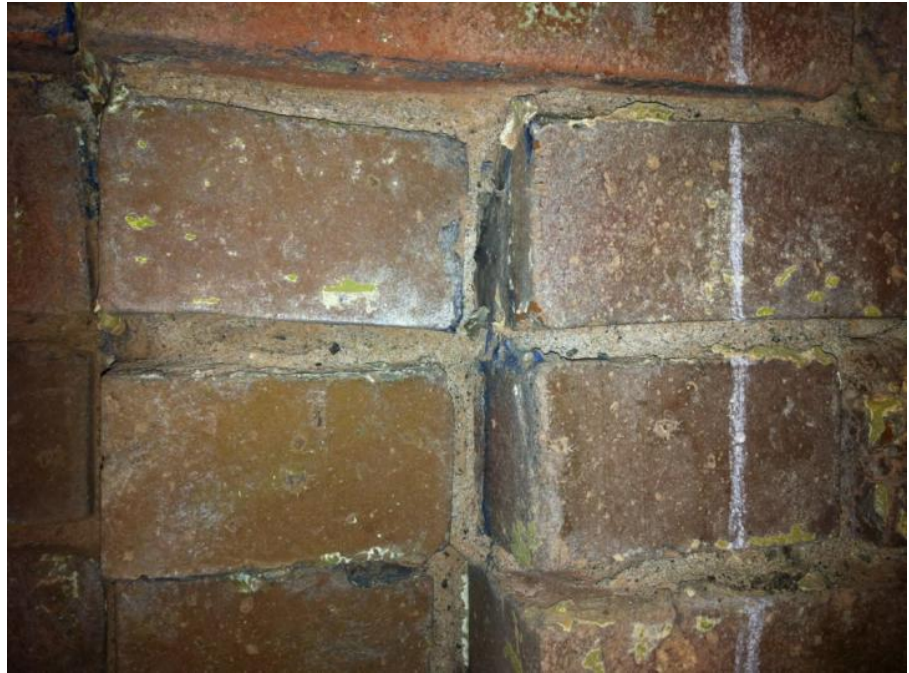
Photograph No. 7

Detailed inspection identified visible paint remaining on both the brick and concrete walls (i.e., **Photos 7, 8, 9, 16, 20, 27, 29**). On the brick wall much of the residual paint occurred in difficult to reach locations, such as bricks in alcoves that faced a nearby wall (**Photo 8**) or bricks near the ceiling (**Photo 9**). The brick/grout interface was also a location where residual paint was frequently observed (**Photo 10**). An estimated average of 96 percent of the paint was removed on the brick surfaces.

Description: Close-up showing
paint bits on brick.

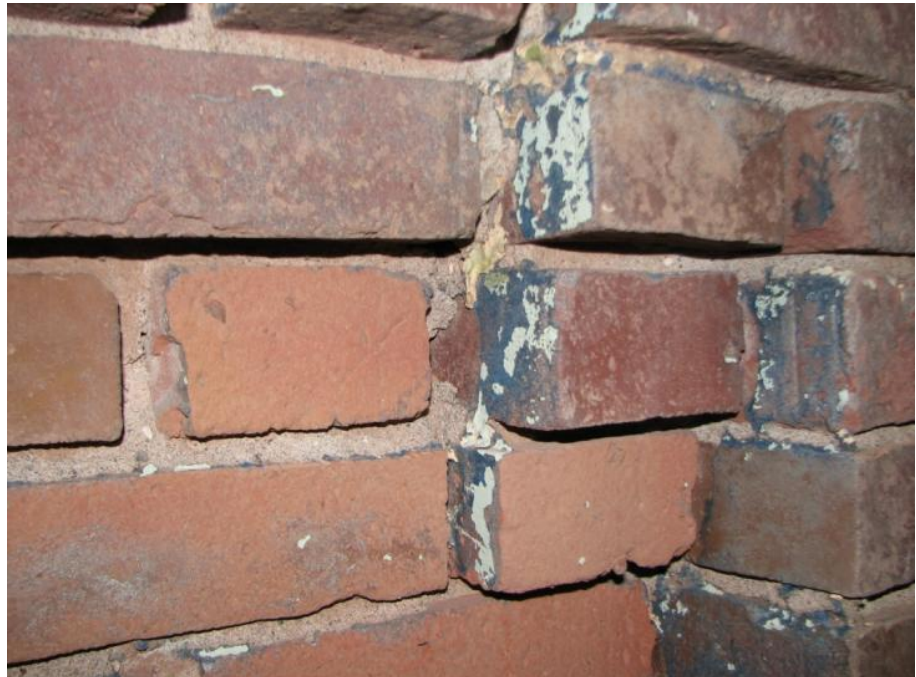
Photograph No. 8

Description: Residual paint on
brick face in Brick Grid A2
(bricks face adjacent wall).

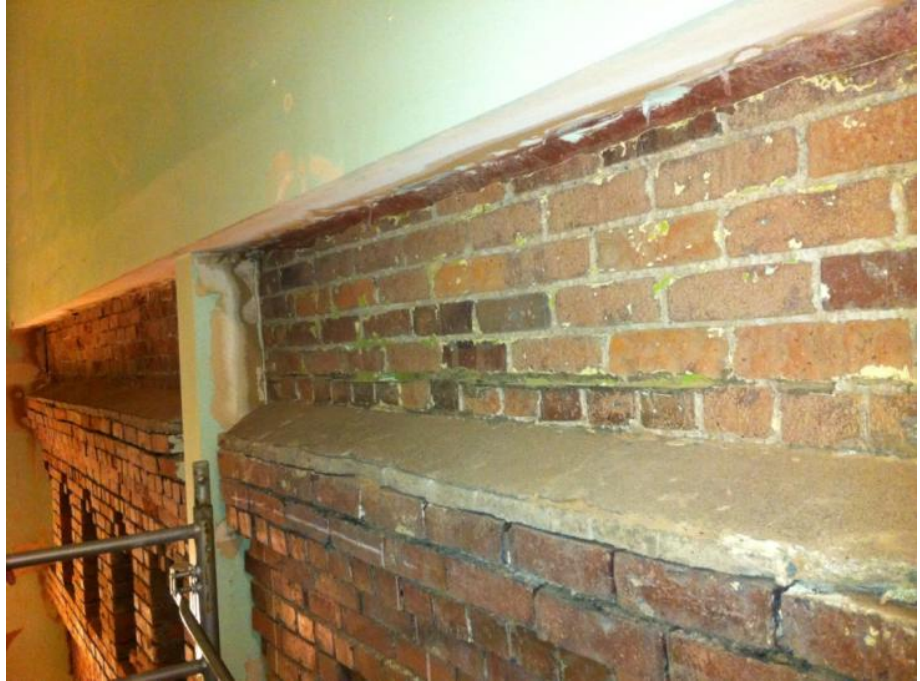
Photograph No. 9

Description: Photo showing
upper portion of brick wall.

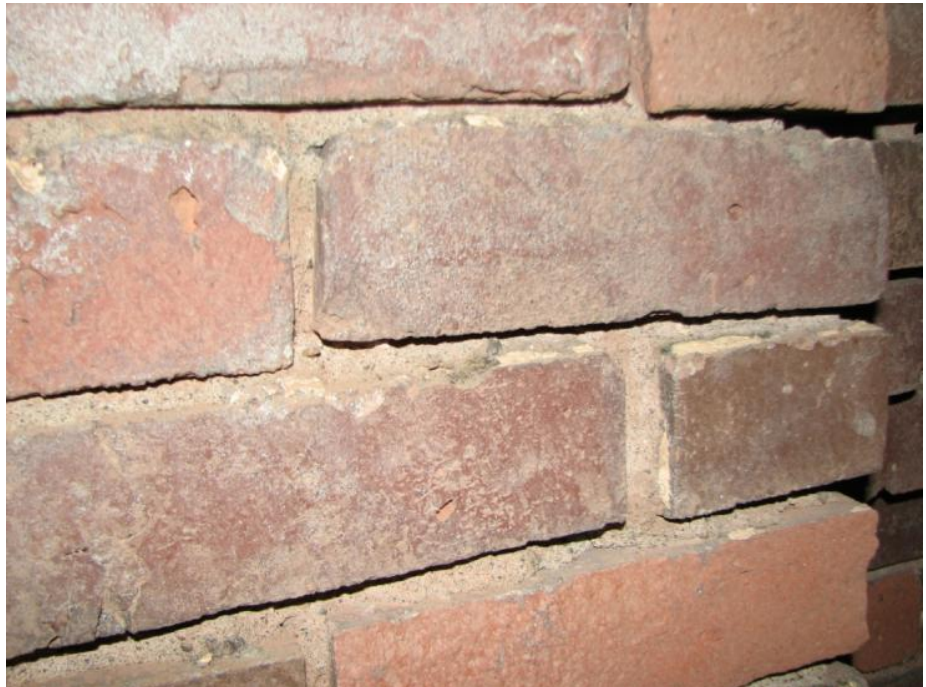
Photograph No. 10

Description: Paint at brick-
grout interface in Brick Grid
A2.

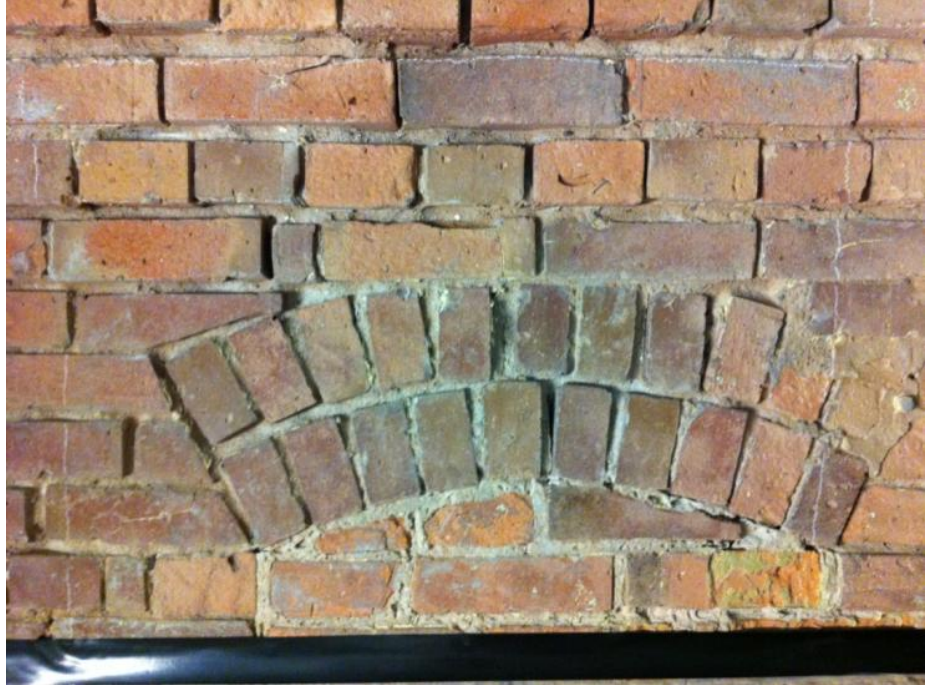
Photograph No. 13

Brick	B4	<ul style="list-style-type: none"> • Approximately 95 % of paint removed. • Paint visible on approximately 15 bricks ranging in size from 1 mm to 3 inches diameter. • Approximately 12 spots of paint on grout/brick interface 1" to 4 inches long and ¼ to ½ inch wide. • Approximately 12 visible spots of paint on grout 1 to 20 mm diameter.
Brick	B6	<ul style="list-style-type: none"> • Approximately 99% of paint removed. • Visible paint on approx. 24 bricks, ranging from 1 mm to 1 inch spots. • Approx. 10 locations with paint in grout ranging from 1/8 inch diameter to 1/8 inch by 1 ¼ inch.
Brick	G2	<ul style="list-style-type: none"> • Approximately 92 % of paint removed. • Paint remains on face of approximately 25 bricks ranging from 1 mm to 2 inches in diameter. • Paint is more predominant on the underlying edge of the alcove where it was difficult to reach with the blaster. • Paint on the brick/grout interface at approximately 22 locations ranging from 1 to 8 inches long and 1/8 to ¾ inch wide. • Within grout – Approximately 5 location with paint ranging from 1mm to ½ inch long

Description: Brick Grid B4.

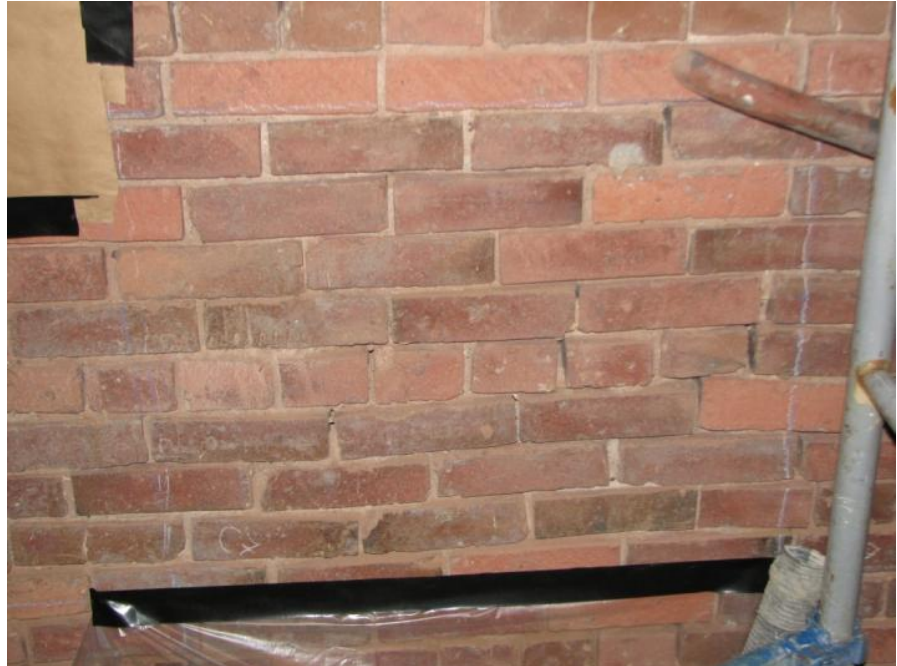
Photograph No. 15

Substrate	Grid Number	Comments from Visual Inspection
Brick	C7	<ul style="list-style-type: none"> • Approximately 99% of paint removed. • Visible paint remains on approximately eight bricks. Visible spots of paint are faded and minimal, ranging from 1 mm to 20 mm diameter. • Visible paint on grout at approximately six locations ranging from 1 to 4 mm except for an approximately 2 inch by ½ inch chunk of paint embedded between bricks. • A concrete repair spot has visible spots of paint.
Brick	A5	<ul style="list-style-type: none"> • Approximately 95% of paint removed. • Thin coats of paint exist on face of 34 bricks ranging in size from ¼ inch diameter to 2 inch long by ¼ inch wide. • Approximately 7 locations with paint lines along the grout/brick boundary ranging from 1 mm to 2 inches long. • Brick in lower right portion of grid has a pronounced residual paint in grout surrounding brick and in crack on brick face.

Description: Brick Grid C7.

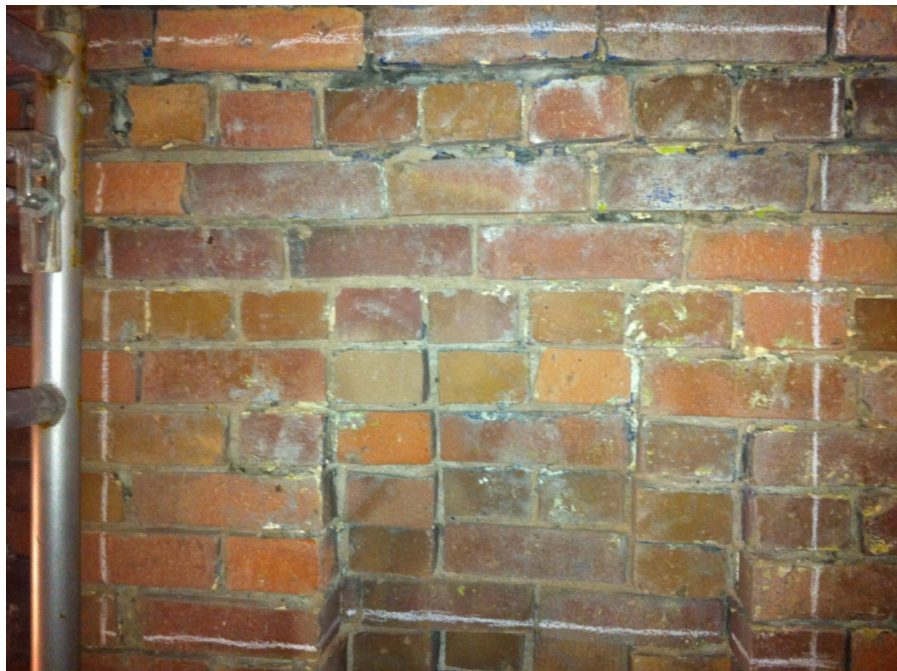
Photograph No. 16

Description: Brick Grid G2.

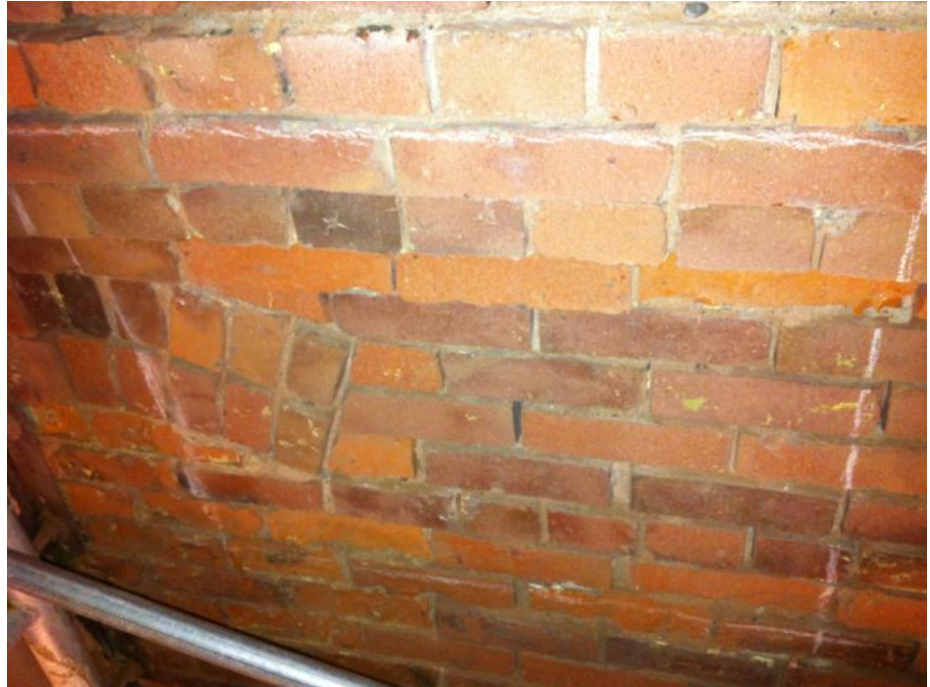
Photograph No. 17

Substrate	Grid Number	Comments from Visual Inspection
Brick	G4	<ul style="list-style-type: none"> • Approximately 97% of paint removed. • Paint remains on face of approximately 17 bricks ranging from 2 mm to 1 inch, mostly in the centrally located bricks on the right and left sides of the grid. • Difficult to reach under hanging edge of the top middle brick has a residual thin layer of paint over much of the brick face. • Paint on the brick/grout interface at approximately 5 locations ranging from 1 to 8 inches long and 1/8 to ½ inch wide. • Within grout - Approximately 5 location with paint ranging from 1mm to ½ inch long.
Concrete	A1	<ul style="list-style-type: none"> • Approximately 95% of paint removed. • Approximately 20 spots of visible paint ranging from 1 mm diameter to ¼ inch by 1 inch long. • Large cut off edge of pipe as small bits of visible paint around the outer edges and inside caulk. • Steel plate in the lower left corner has paint remaining around the edge.

Description: Brick Grid G4.

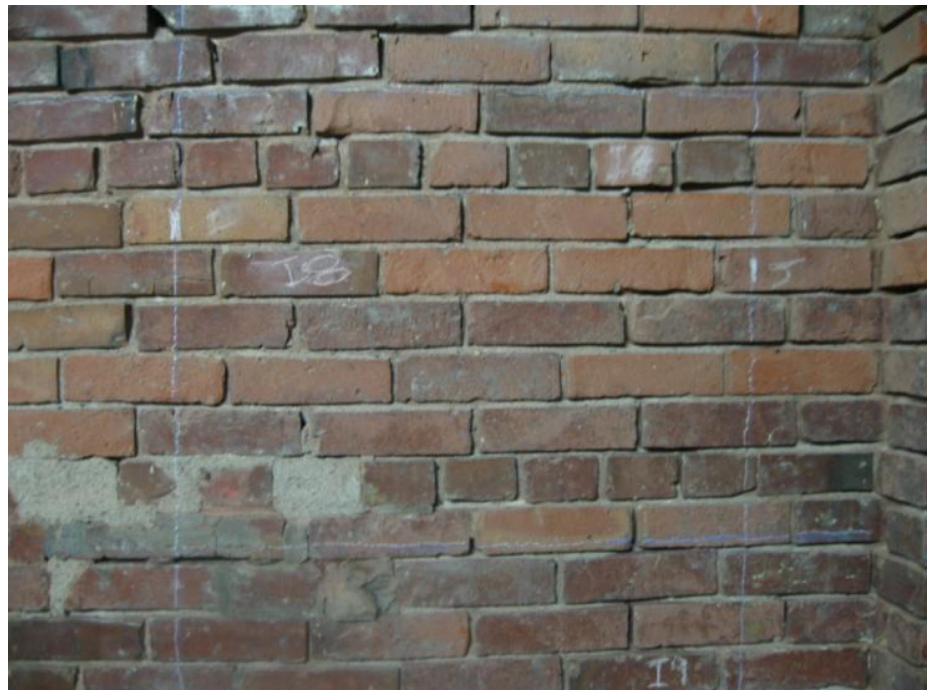
Photograph No. 18

Substrate	Grid Number	Comments from Visual Inspection
Brick	I8	<ul style="list-style-type: none"> Approximately 99% of paint removed. Less than ten visible spots of paint on the brick surfaces, none greater than 3 mm in diameter. Paint on the brick/grout interface at approximately 4 locations ranging from ¼ to 2.5 inches long and 2 mm to 3/8 inch wide. Grout is clean with no visible paint remaining.
Brick	I10	<ul style="list-style-type: none"> Greater than 95% of the paint removed. Approximately 30-40 spots of paint visible on face of brick ranging from 1 mm to 1 inch diameter. Visible paint primarily concentrated along the bottom five rows of the grid element adjacent to the floor where it was difficult to reach and the tape covered the bottom edge. Spots range from 1mm to 1-inch in diameter, but are predominantly 1/8 to ¼-in. Grout/brick interface has approximately 5 lines of paint remaining up to 5-in long and ¾ -in wide. Most of the grout has been removed in some areas.

Description: Brick Grid I8.

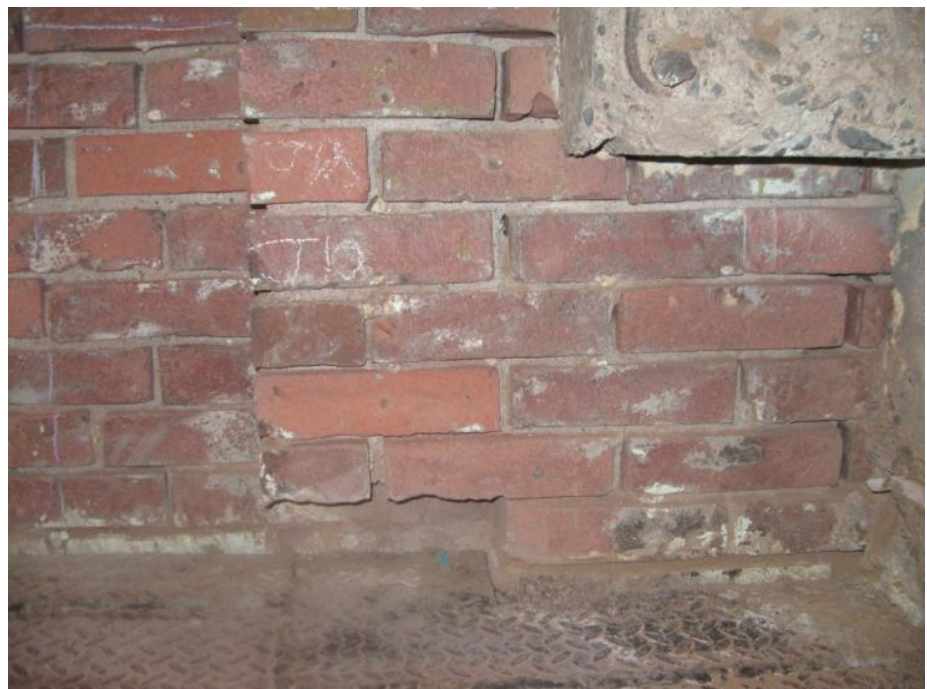
Photograph No. 20

Brick	J10	<ul style="list-style-type: none"> Greater than 95% of the paint removed. Paint remains on bricks that extend below floor grate, which was covered by the tape. Approximately 20 spots of paint remain on face of brick ranging from 3 mm diameter to 2-in long by 5/8-in wide. Additional concentration of 1 to 3-inch paint spots in bottom right corner of grid element. Most of the grout has been removed in some areas.
Brick	A2	<ul style="list-style-type: none"> Approximately 98% of the paint removed. Visible paint on 10 to 20% of the bricks, primarily on the grout/brick interface up to ¼ wide by 1 inch long. Spots of visible paint on the grout in approximately six locations. Brick on right under hang of side alcove still has 20 to 60% residual paint layer on approximately 6 bricks.

Description: Brick Grid J10.

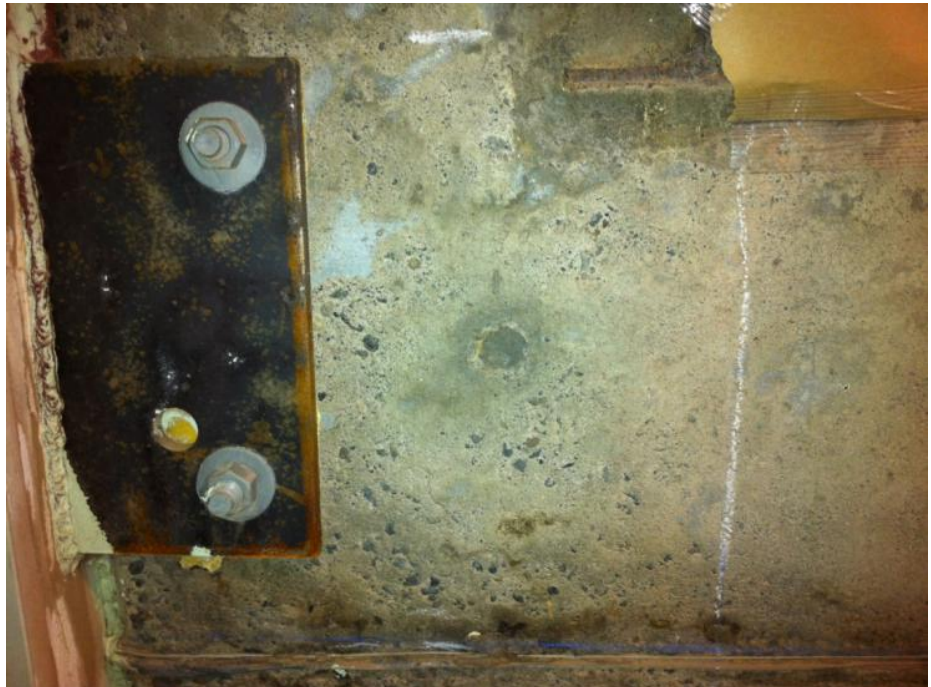
Photograph No. 22

Concrete	A6	<ul style="list-style-type: none"> • Approximately 99% of paint removed. • Approximately 10 visible spots of paint ranging from <1 mm to 1 ¼ inch diameter. • Steel plate on left side of grid with paint in some locations along the edge and in the hole..
Concrete	B4	<ul style="list-style-type: none"> • Approximately 99 % of paint removed. • Approximately 10 spots with visible paint, 1 mm to 1/8 inch. • I-beam in left middle portion of grid appears to have grout with numerous (>20) 1 mm or less spots of visible paint.
Concrete	B5	<ul style="list-style-type: none"> • Approximately 97 percent of paint removed. • Approximately 10 locations with visible paint <1 mm to 1/ 8 inch in size. • I-Beam in left middle portion of the grid has approximately 20 small (1 mm or less) spots of paint.
Concrete	C6	<ul style="list-style-type: none"> • Approximately 96 % of paint removed. • Bottom I-beam present in upper right corner and plastic pipe present in middle bottom of grid. • Approximately 30 visible spots of paint < 1mm to 1.5 inch diameter mainly in middle portion of grid. • Visible paint present on end of pipe sticking out of grid. Pipe itself it filled with a red grout.

Description: Concrete Grid A6.

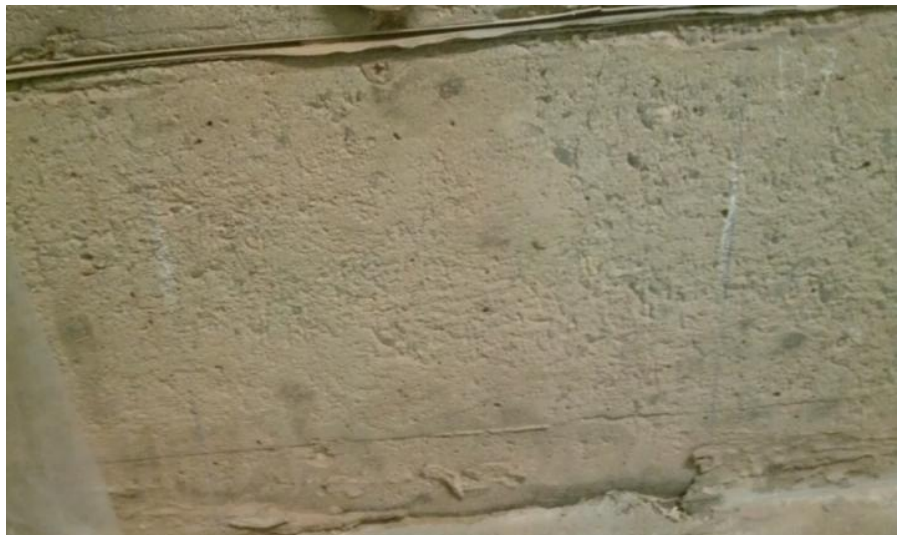
Photograph No. 26

Substrate	Grid Number	Comments from Visual Inspection
Concrete	C7	<ul style="list-style-type: none"> • 100 % of paint removed. • No visible paint
Concrete	E1	<ul style="list-style-type: none"> • Approximately 80% of paint removed. • Approximately 20 spots of visible paint 1 mm to 1.5 inch diameter • Residual thin layer of paint remains in spots up to 1" x 6".
Concrete	F6	<ul style="list-style-type: none"> • Approximately 60% of paint removed. • Grid is located within cinder blocks. Numerous 1-2 mm spots of visible paint within the cinder blocks.
Concrete	G1	<ul style="list-style-type: none"> • Approximately 70% of paint removed. • Approximately 10 spots of visible paint <1mm to 2 inches diameter. • Residual thin layer of paint remains in large portions of the grid.
Concrete	G4	<ul style="list-style-type: none"> • Approximately 99% of the paint removed. • Approximately 12 visible spots of paint <1 mm to ¼ inch diameter.

Description: Concrete Grid C7.

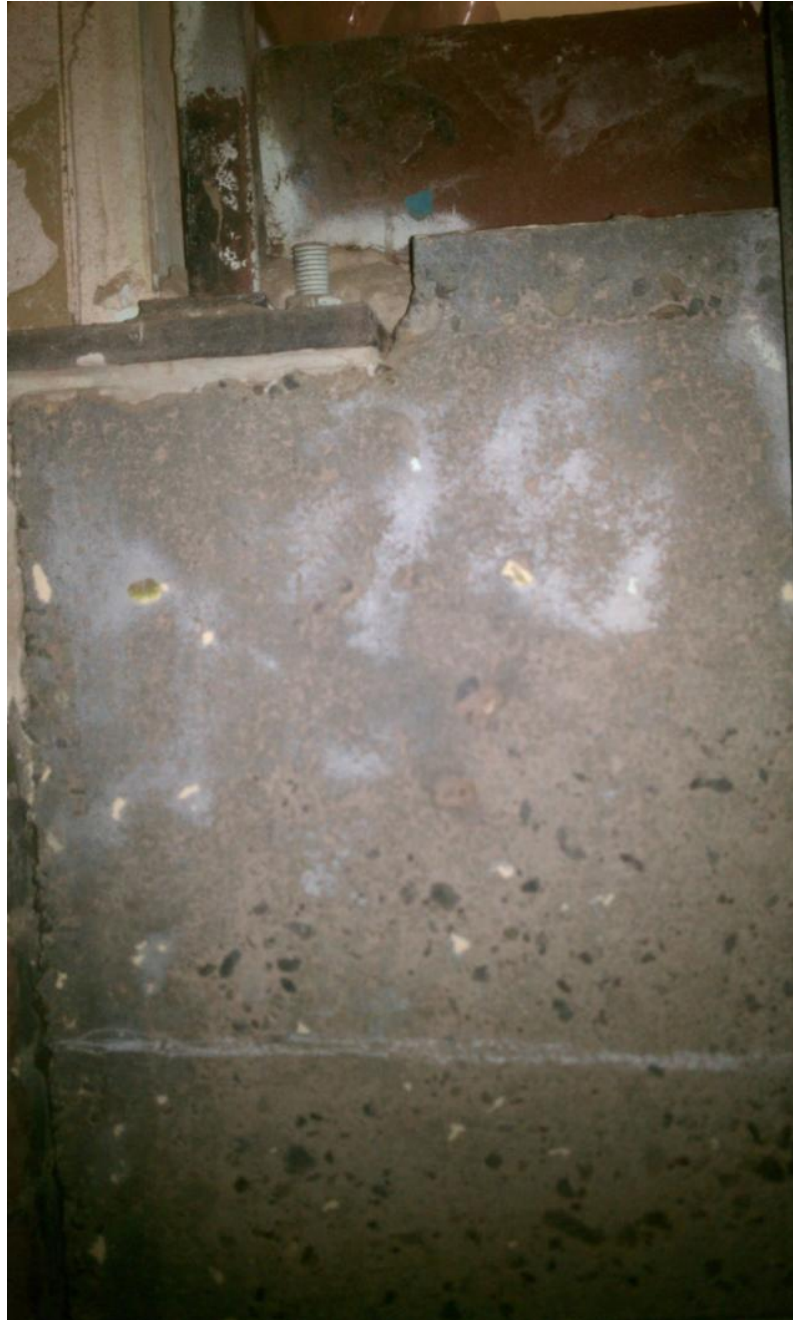
Photograph No. 27

Description: Concrete Grid E1.

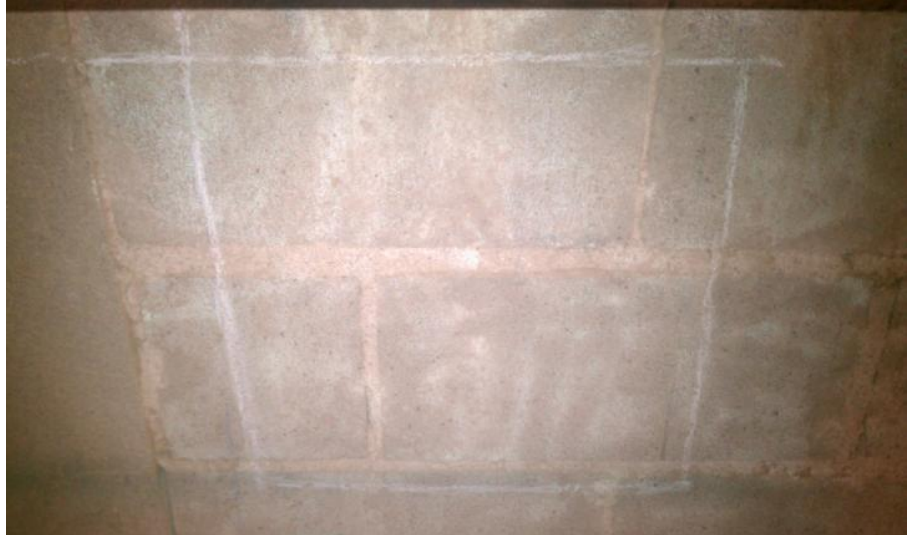
Photograph No. 28

On the concrete surfaces, a very thin residual paint layer was observed across some areas (**Photo 29**). Small pores in the cinder blocks appeared to have retained bits of paint (**Photo 28**). In other areas, small remnant paint bits were thicker (**Photo 27**). On average, an estimated 90 percent of the paint was removed from the concrete surfaces.

Description: Concrete Grid F6.

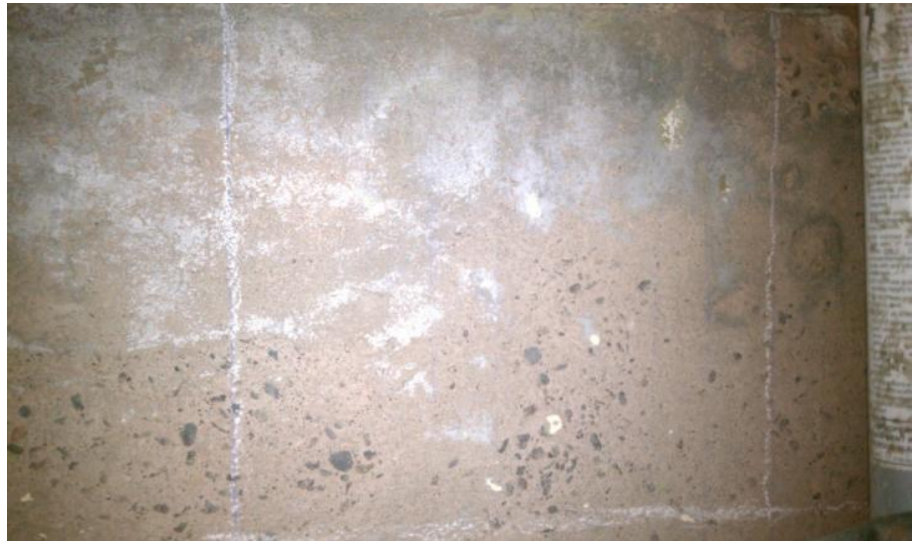
Photograph No. 29

Description: Concrete Grid G1.

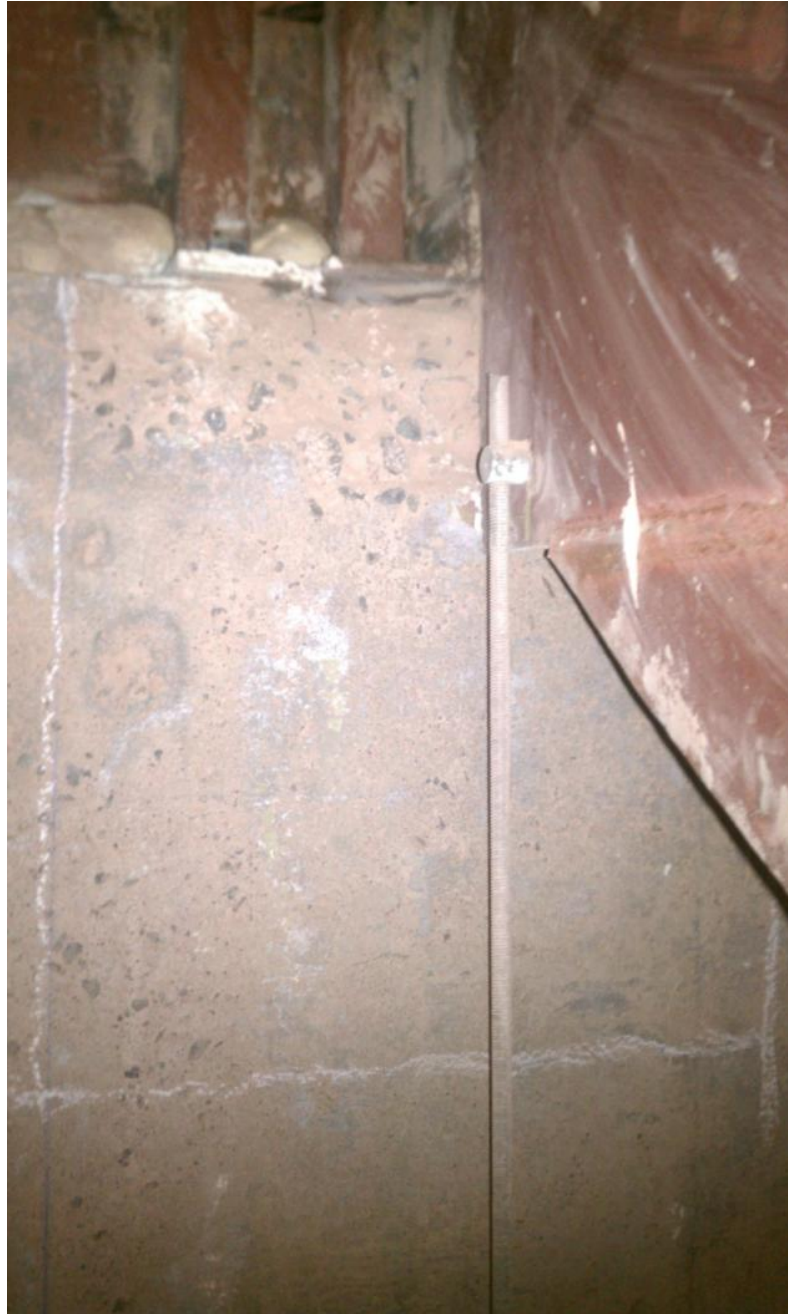
Photograph No. 31

Concrete	H1	<ul style="list-style-type: none"> • Approximately 95% of the paint removed. • Approximately 5 spots of visible paint remain < 1 mm to 1 inch diameter. • Residual thin layer of paint remains spots 1 to 3 inch diameter.
Concrete	H10	<ul style="list-style-type: none"> • Approximately 90% of paint removed. • Approximately 24 visible spots of paint < 1mm to 2 inches diameter. • Large structural column of different concrete occupies most of the grid.

Description: Concrete Grid H1.
